A DESCRIPTIVE STUDY OF THE RADIOGRAPHIC DENSITY OF IMPLANT RESTORATIVE CEMENTS

Chandur Wadhvani, BDS, MSD,^a Timothy Hess, DDS,^b Thomas Faber, DDS, MSD,^c Alfonso Piñeyro, DDS,^d and Curtis S. K. Chen, DDS, MSD, PhD^e
University of Washington, Seattle, Wash

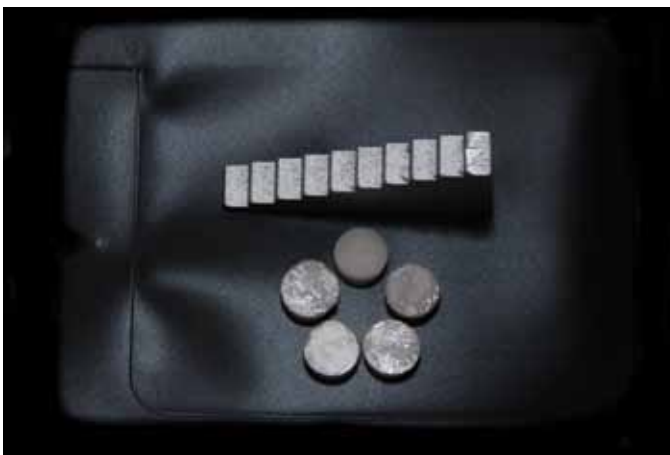
**1** Specimen disks with modified step wedge.

Melville, NY). A 98% pure aluminum step wedge (DHEF, Inc, Taipei, Taiwan) was placed adjacent to the specimens, near the center of the PSP image plate (Fig. 1). The wedge increased in incremental, millimeter-thick steps from 1 mm to 10 mm.
